# Arboricultural Impact Assessment and Tree Protection Plan

Land to the west of Wales One, Magor

Nick Baxter BSc (Hons) TechArborA  
Arboricultural Consultant

2<sup>nd</sup> February 2022

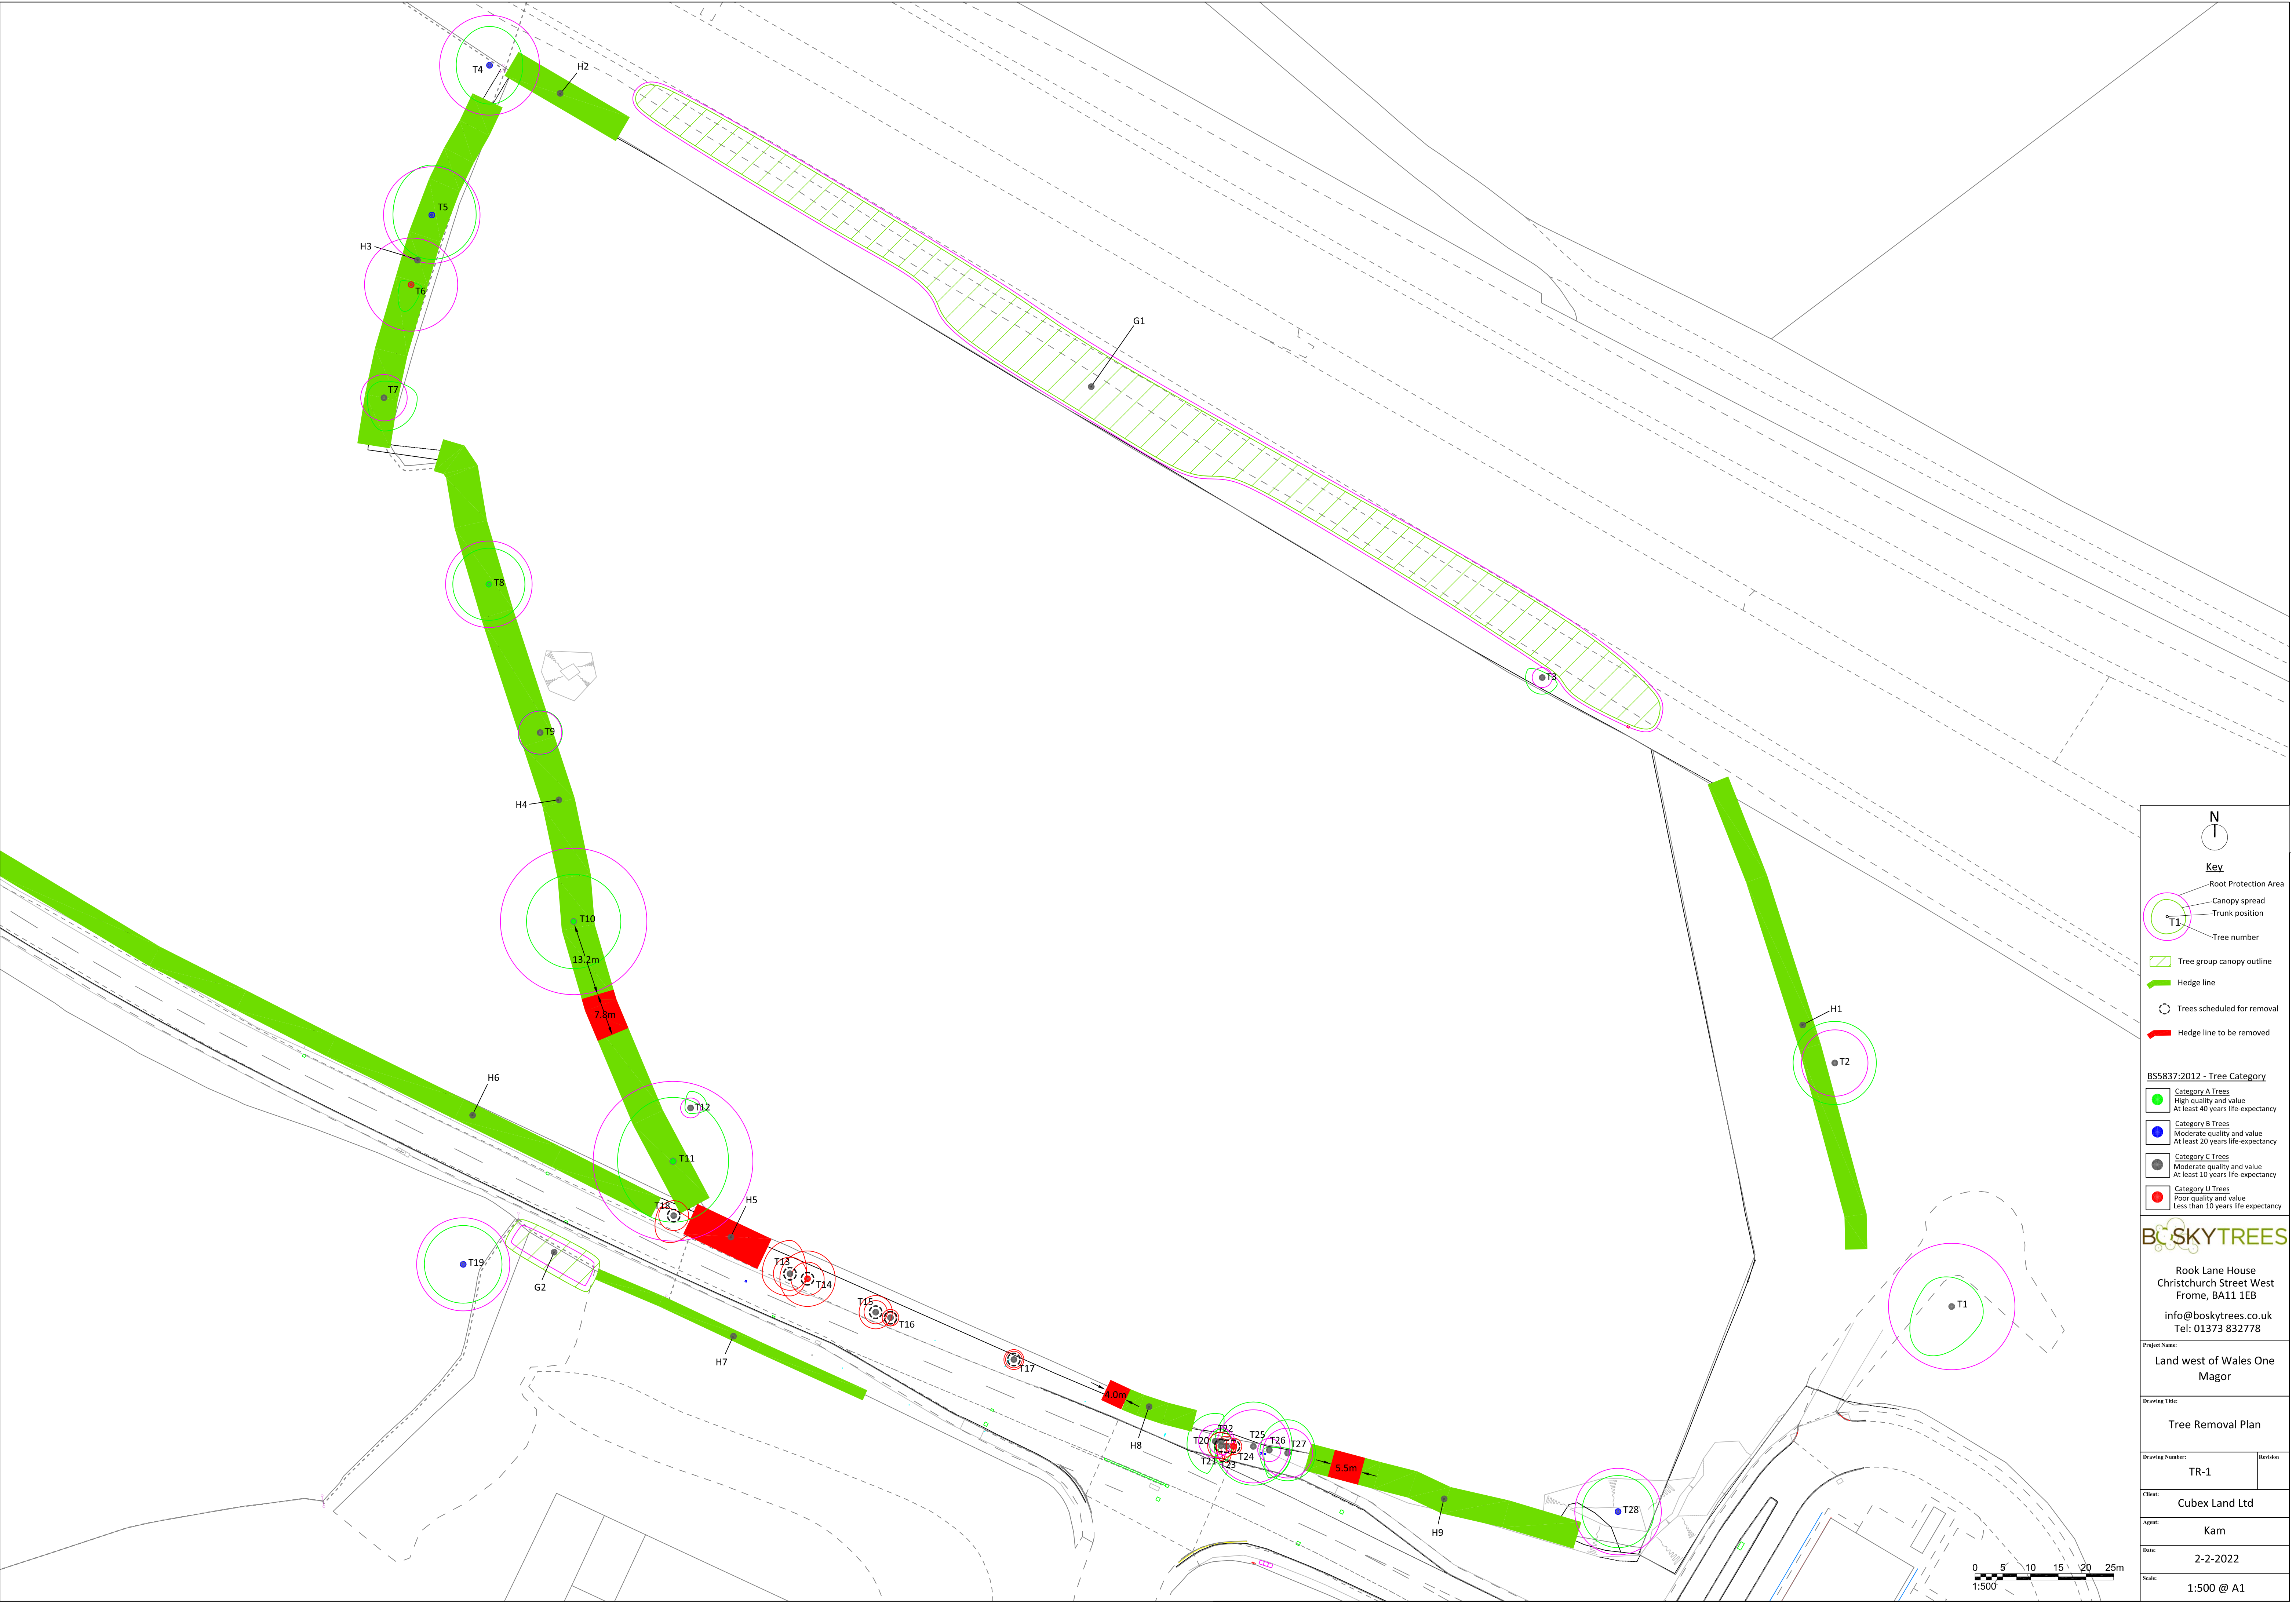
Appendix 3: Tree removal plan (TR-1)

The tree removal plan (TR-1) shows the root protection areas required by each tree and identifies which trees are to be removed to enable the proposed development. The tree protection plan (TPP-1) shows where fencing and other protection measures are required to safeguard trees during construction. These plans are provided at the rear of the report.

Seven C-grade trees (T13, T15–T18, T21 & T23) will need to be removed in order to construct the proposed development. Additionally one short section of hedge (H5), and part of three further hedges (H4, H8 & H9) will also need to be removed, these are all C-grade arboricultural features.

The removal of two further trees (T14 & T24) is recommended because they are in poor condition and have less than ten years useful life expectancy, i.e. their removal is recommended regardless of any development proposals. These trees are considered to be category U in accordance with the guidance provided in Table 1 of BS5837.

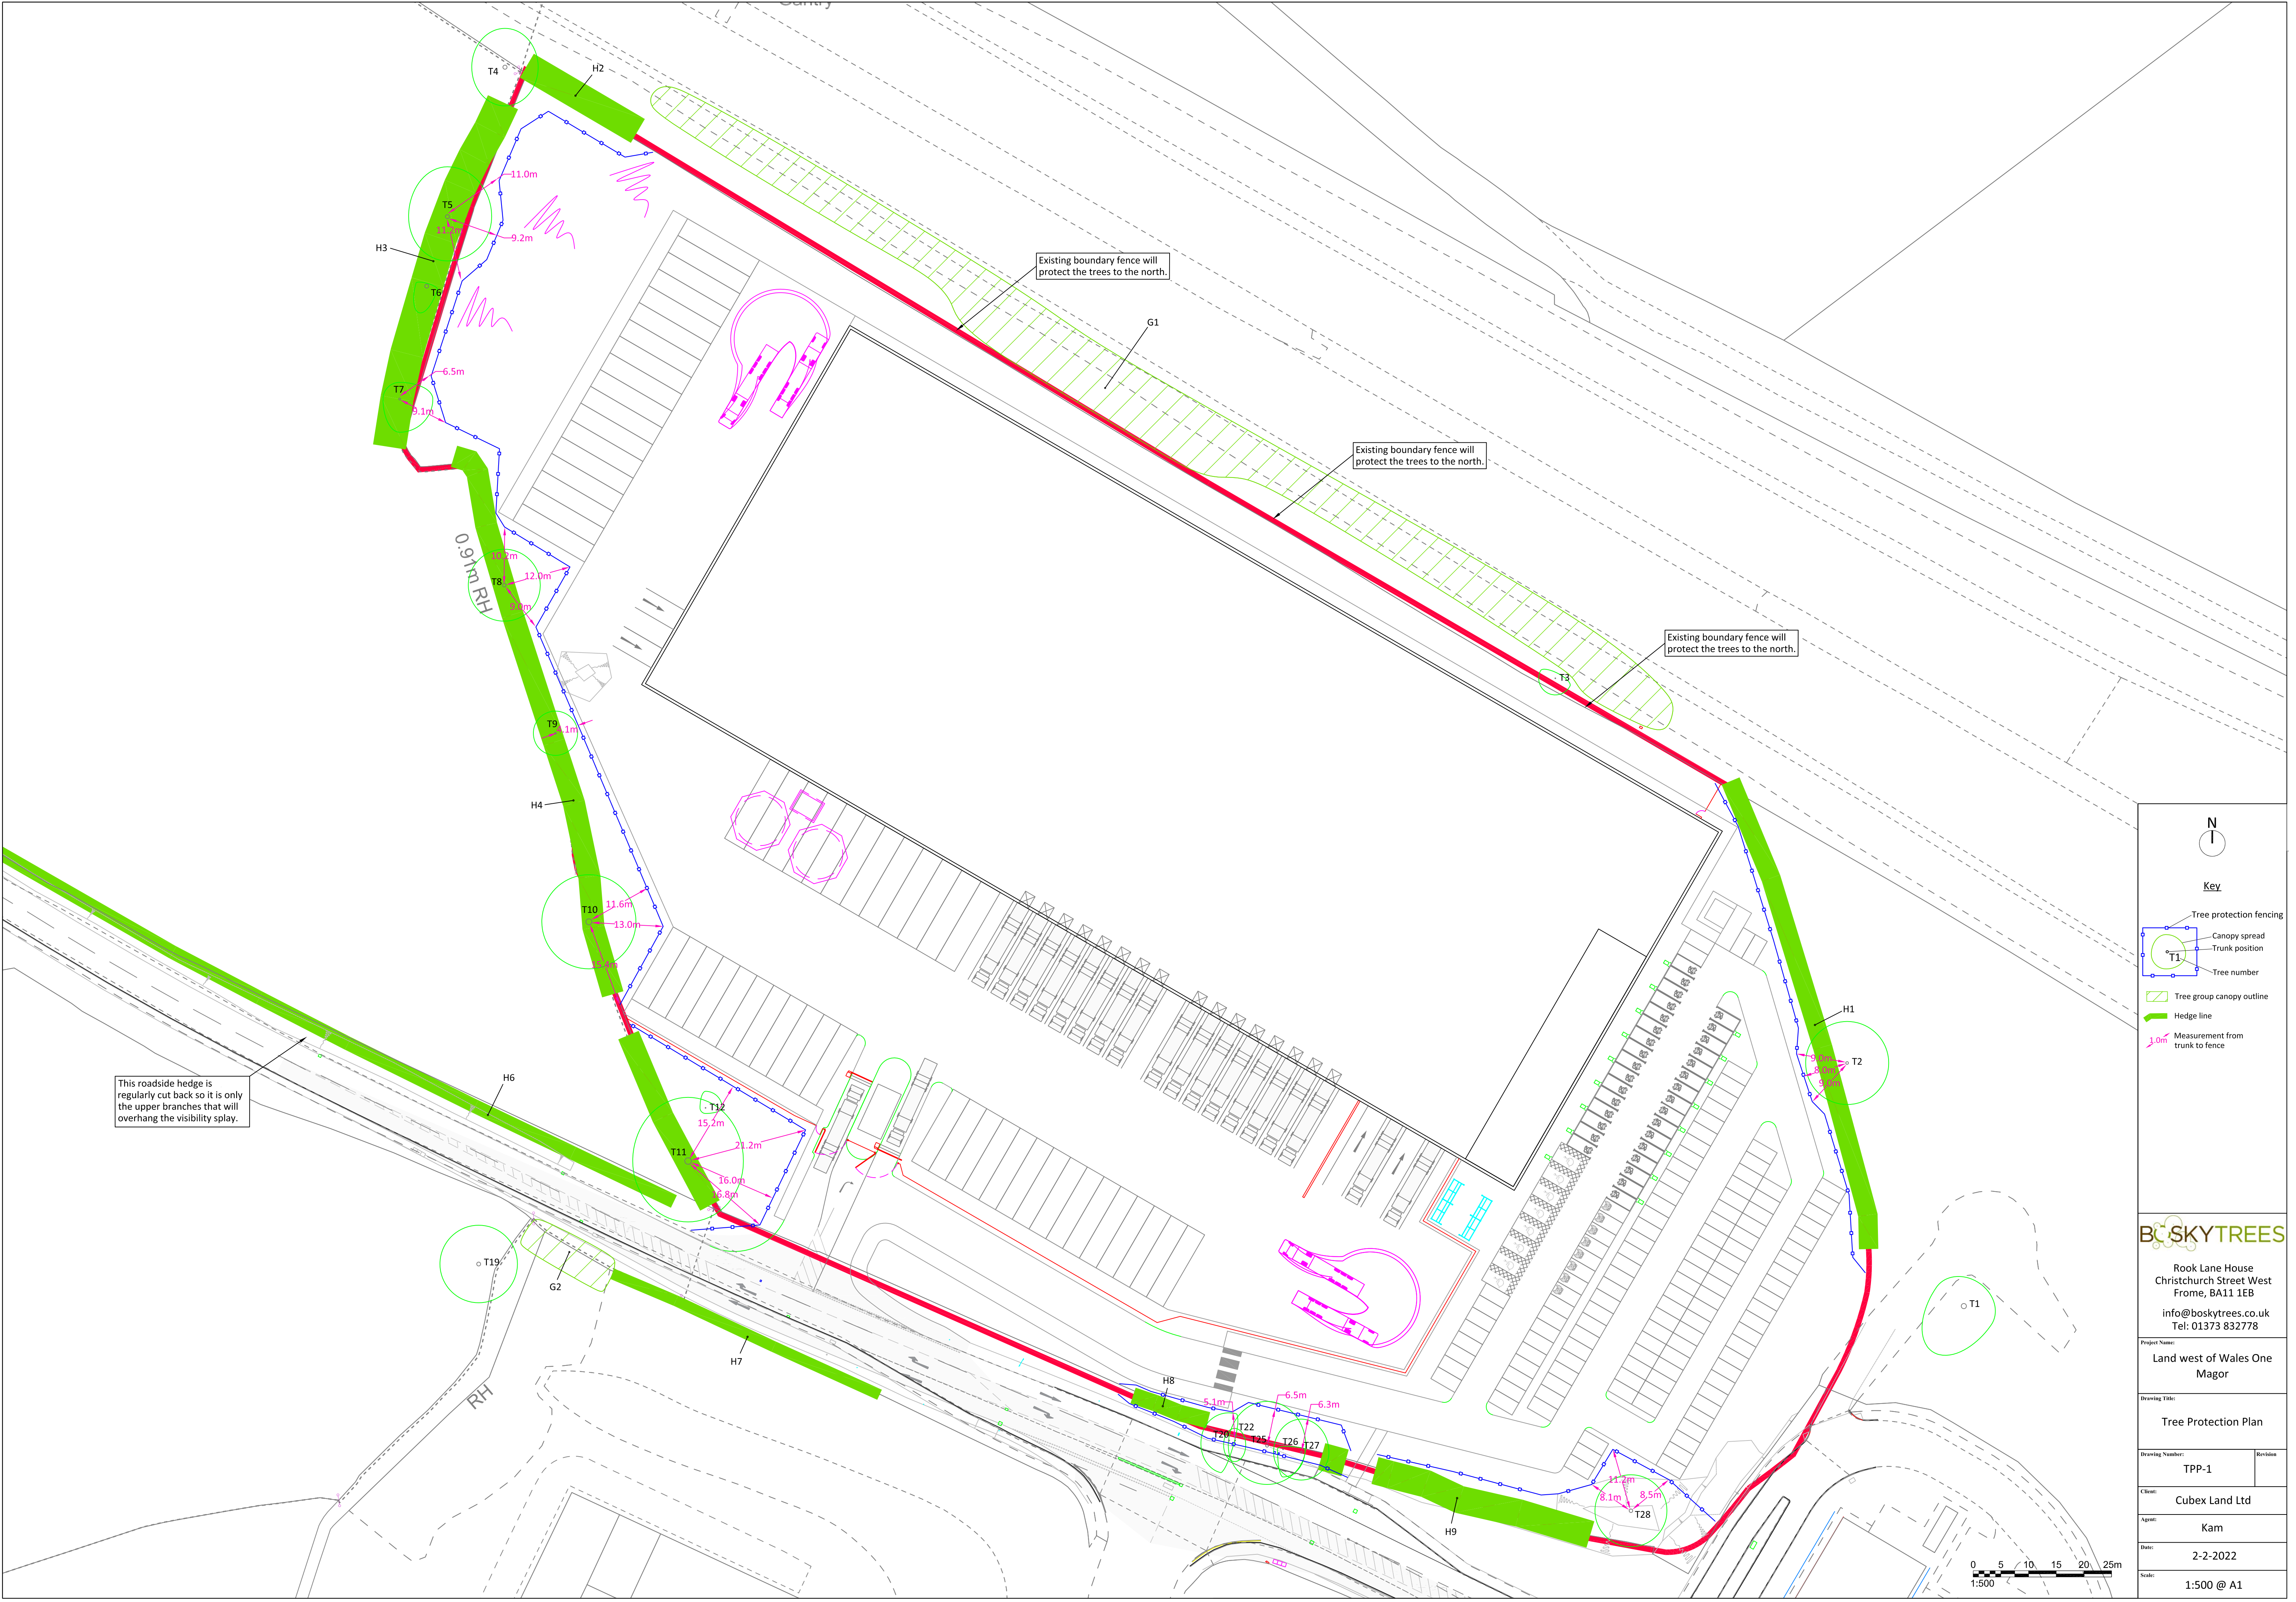
Appendix 4: Tree protection plan (TPP-1)

Temporary fencing and/or barriers must be used during construction to protect retained trees situated near works areas. The locations of such fencing/barriers is indicated on tree protection plan at the rear of the report (TPP-1). For effective tree protection, protective fencing must be installed before any heavy plant machinery is used on the site and must remain in place until completion of construction works (unless under arboricultural supervision). The fenced off areas will be designated as 'construction exclusion zones'.
